## **Lost Turf: Report on Calton Hill Re-grassing, May 2025 to January 2026**

*Calton Hill grass re-turfing and re-seeding, May 2025 to January 2026*

CHCT 2 February 2026

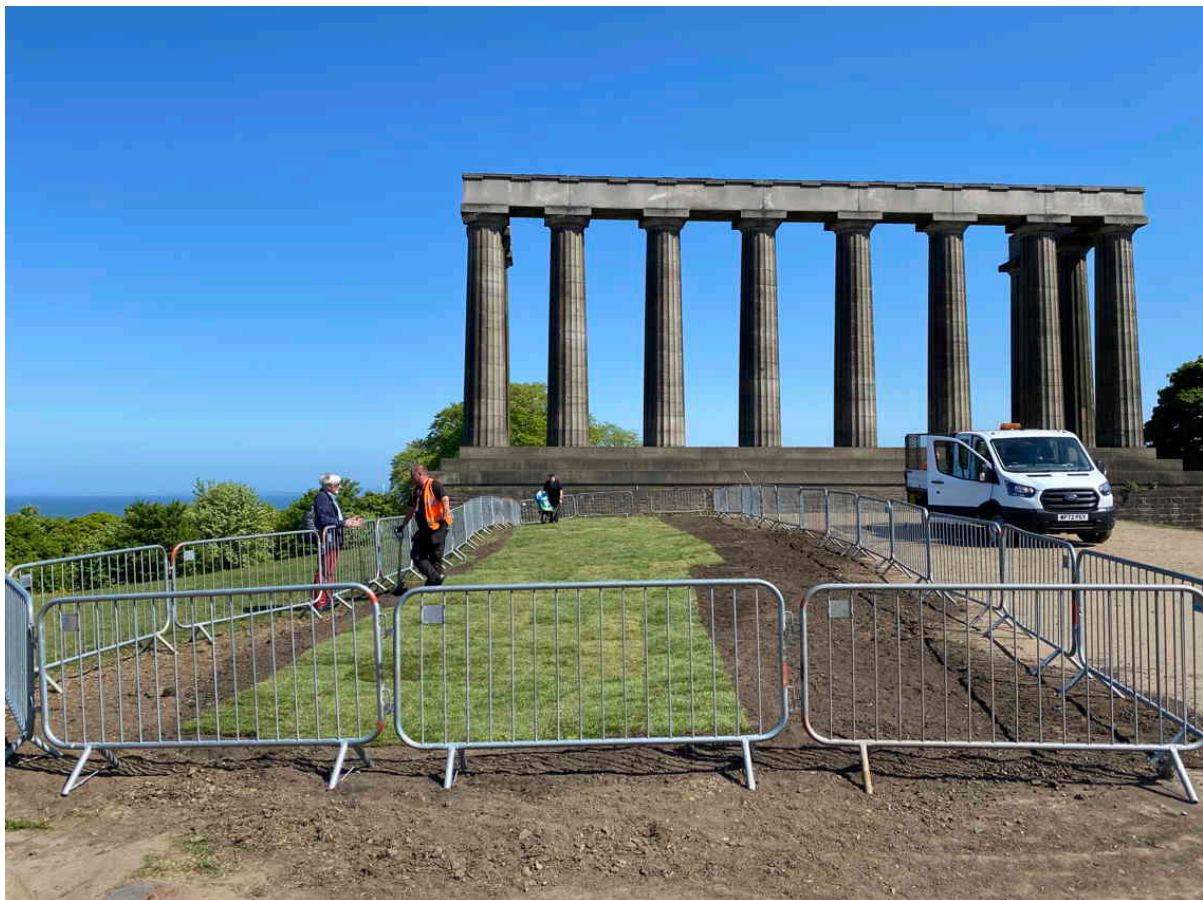
Following ground preparation with rotavation, removal of stones and the spreading of screened top soil brought to the hill by truck, volunteers and park rangers laid 120 square metres of turf in a 30m by 4m rectangle, with an equal surrounding area reseeded with rye grass seed.

We used rhizomatous tall fescue (RTF), a durable, dense, hard-wearing turf with underground stems called rhizomes, that allow the grass to spread and repair itself.

*Photo 1: Returfed strip surrounded by the area of reseeded, 5 May 2025*

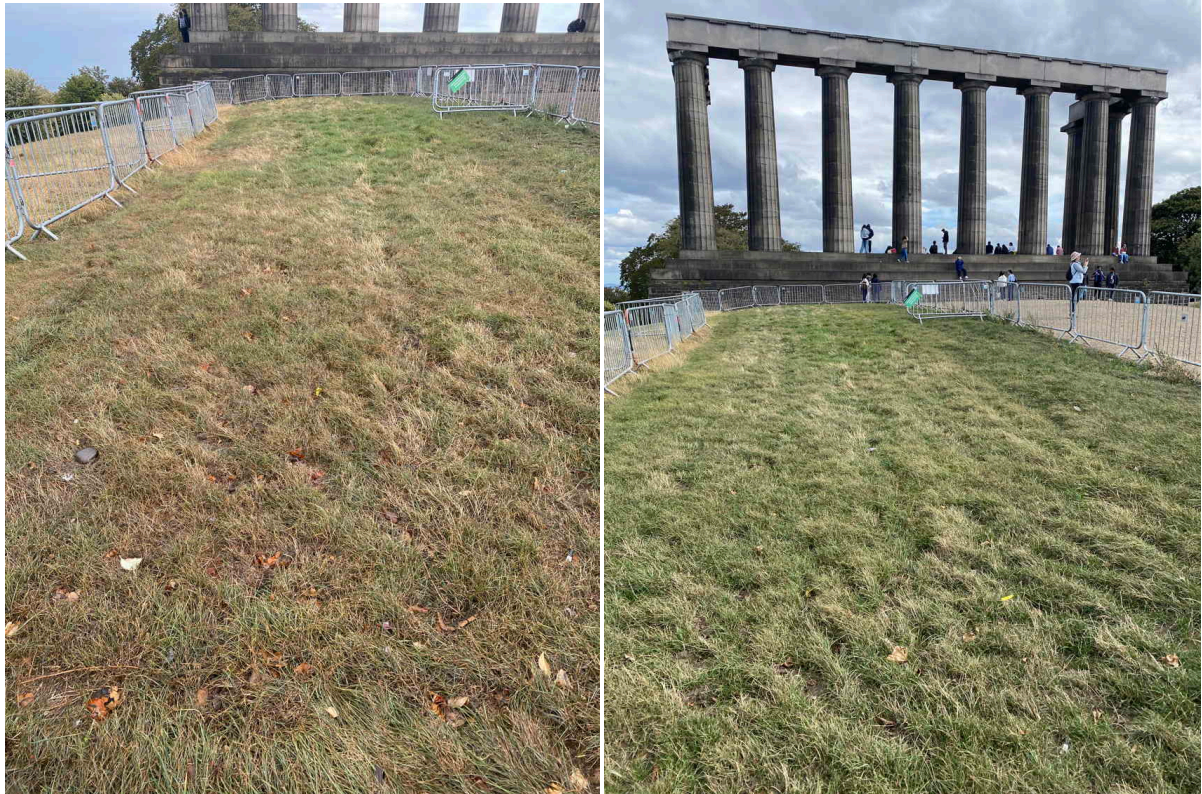
Nevertheless the grass gradually recovered and began to grow back.

*Photo 4 and 5: 28 August and 9 September 2025*

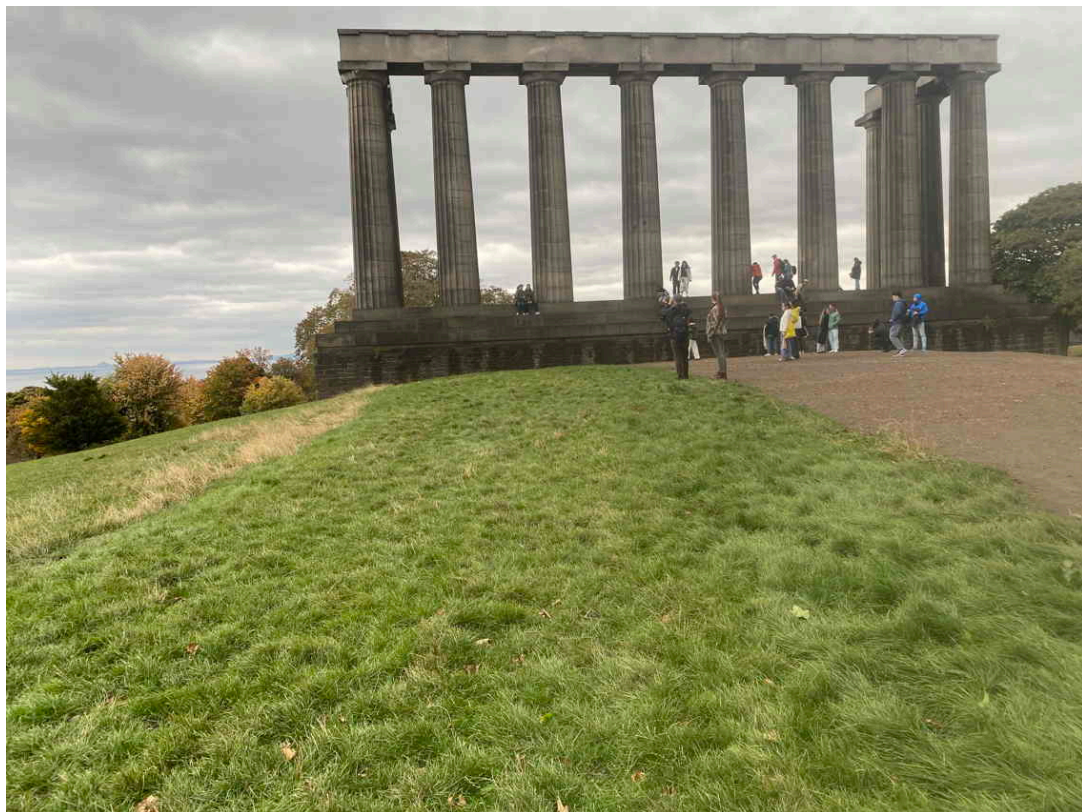
On 1 October 2025, the 'crowd control' fencing was removed.

*Photo 6: Returfed and reseeded area after removal of fencing, 1 October 2025*

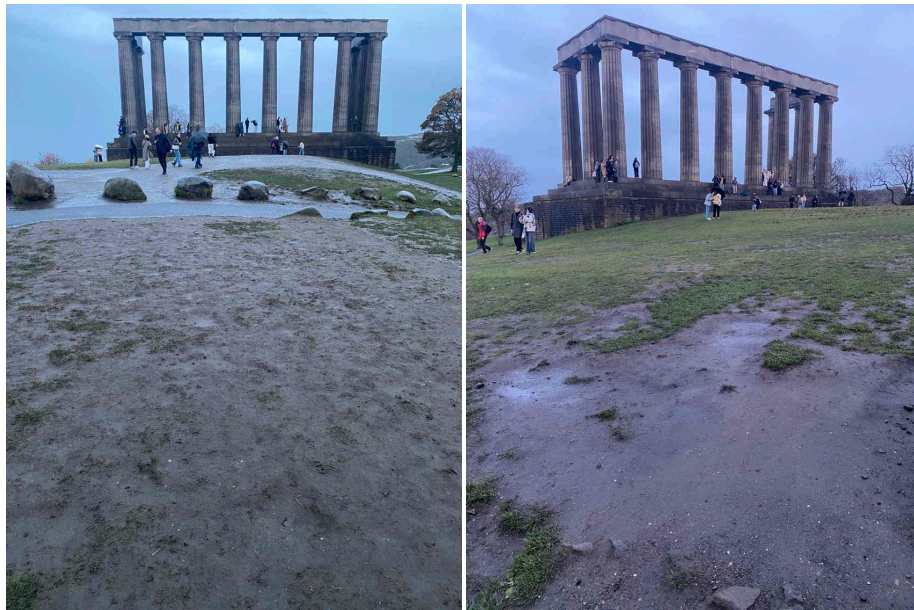
Unfortunately during the autumn, there was rapid and accelerated deterioration in the condition of the turf as a result of increased footfall. The Samhuinn event on 31 October saw particular damage.

Photo 7 and 8: Around the re-turfed area following the Samhuinn, 4 November 2025

We are aware that other major heritage monuments, such as Stonehenge, have a rolling programme of resting (roping off) areas of grass to allow it to recover. This approach has been agreed with the council in principle but so far not implemented.

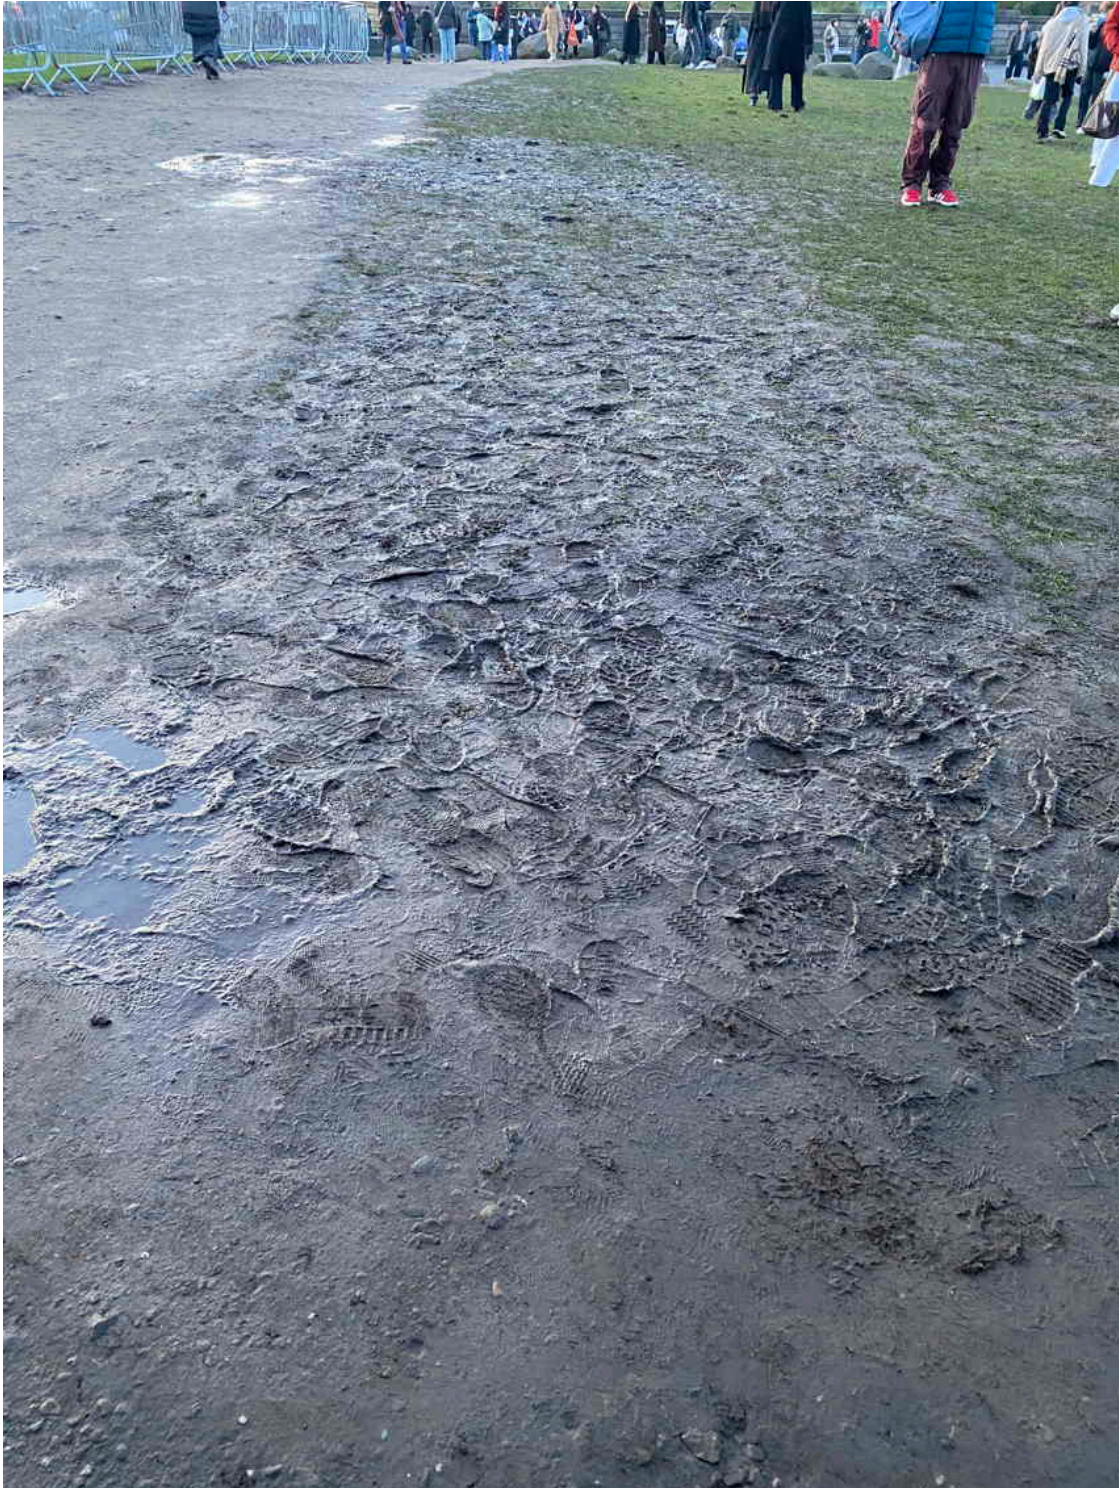
*Photo 10: Highly-stressed rectangle in front of the National Monument, perhaps as the result of an event? 22 December 2025*
